MD146 over Overshot Run

MARYLAND INVENTORY OF HISTORIC BRIDGES  
HISTORIC BRIDGE INVENTORY  
MARYLAND STATE HIGHWAY ADMINISTRATION/  
MARYLAND HISTORICAL TRUST

MHT No. BA-2791

SHA Bridge No. 3306 Bridge name MD 146 over Overshot Run

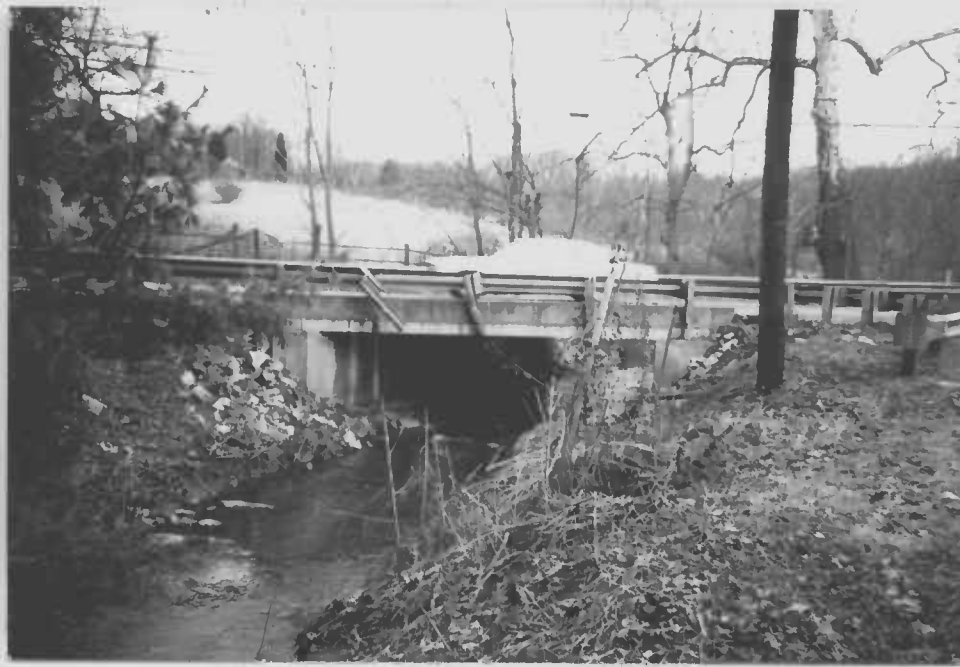
The original parapets were removed and replaced with guard rails at an unknown date. Inspection reports from 1996 detail the repair of both concrete abutments in 1990.

1. BA-2791
2. MD 146 Over Overshot Run
3. Balto Co. MD
4. Eric Gruffitts
5. 3/97
6. MD SHPD
7. existing wings wall + repaired about
8. 5 of 6

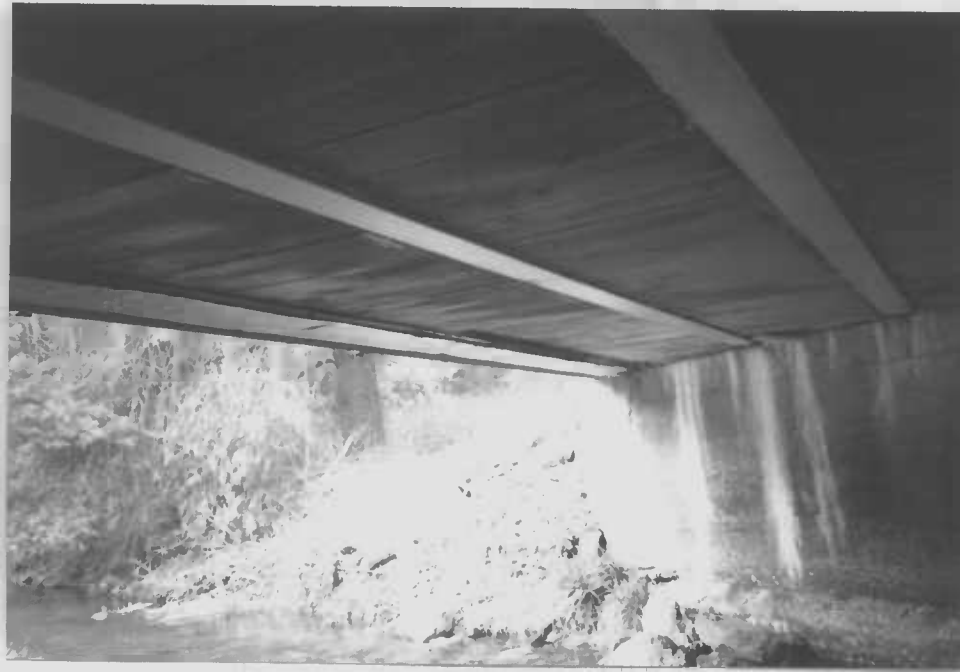
According to the 1996 inspection report, this structure is in fair condition with moderate amounts of rust on the girders. The concrete abutments have moderate erosion on the faces with fine to 1/16-inch irregular cracks.

1. BA-2791
2. MD 146 over Overshot Run
3. Balto Co. MD
4. Eric Gruffitts
5. 3/97
6. MD SHPO
7. girders & planking under bridge
8. 6 of 6
